Drew Point No. 1 Well Plugging – 2010

Operations Summary

Drew Point Well No. 1

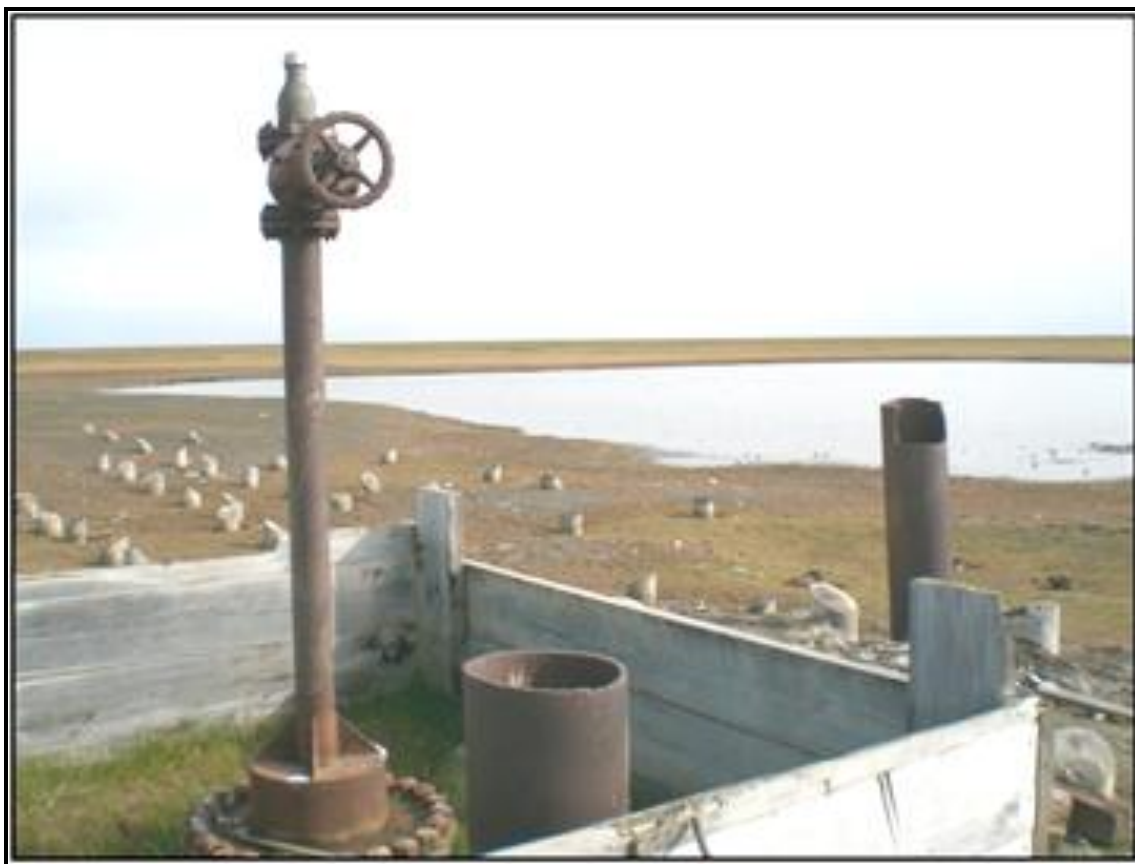
Figure 4: Drew Point No. 1 wellhead – August 2006 – Facing Southeast

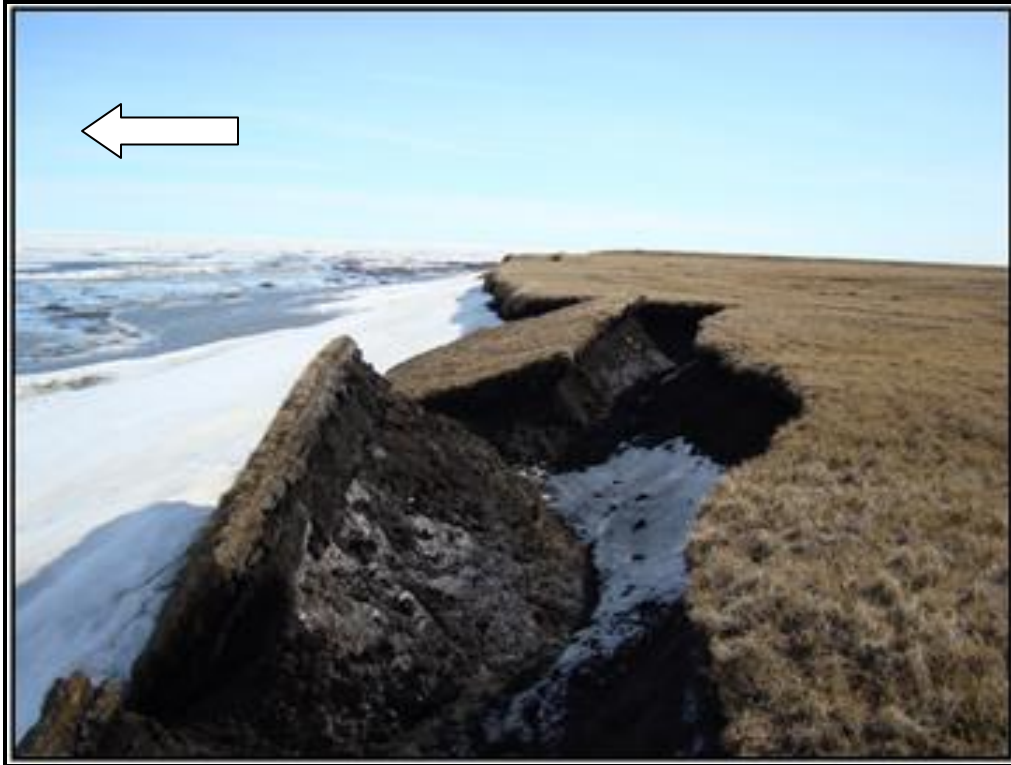
Figure 6: Coastal erosion on Beaufort Sea – June 2007 – Facing East

The well was drilled in 1978 on Federal NPRA lands at Drew Point on the Beaufort Sea coast as part of the USGS exploration efforts in the National Petroleum Reserve - Alaska. Due to its close proximity to the Beaufort Sea coast and prevailing winds, significant shoreline erosion had advanced into the well location requiring the BLM to complete plugging and abandonment of the wellbore and well site. The well was left suspended and plugged back to 2,153 feet with diesel left in the wellbore. The USGS had been actively using the well for permafrost temperature measurements prior to 2010. Diesel fuel inside the wellbore had been used as a non-freezing medium to aid in conducting the temperature measurements. During well plugging operations, approximately 13,380 gallons of diesel fuel was displaced with NaCl (salt) saturated water prior to completing final plugging operations. The NaCl water was then evacuated from the casing down to a depth of 114 feet below ground level (BGL) and an inflatable plug was run and set at this depth using nitrogen pressure from the surface. Cement was mixed at 15.7 ppg and dumped on top of the plug filling the casing to the surface. The frozen earth around the wellhead was excavated down to 30 feet BGL, the wellhead was cut off 29 feet BGL (8 feet below Mean Sea Level, 6 inches of the 13-3/8" x 20" annulus was filled with cement, an identification plate was welded onto the cut off casing, and the excavated hole was backfilled with clean dirt to four feet above ground level.

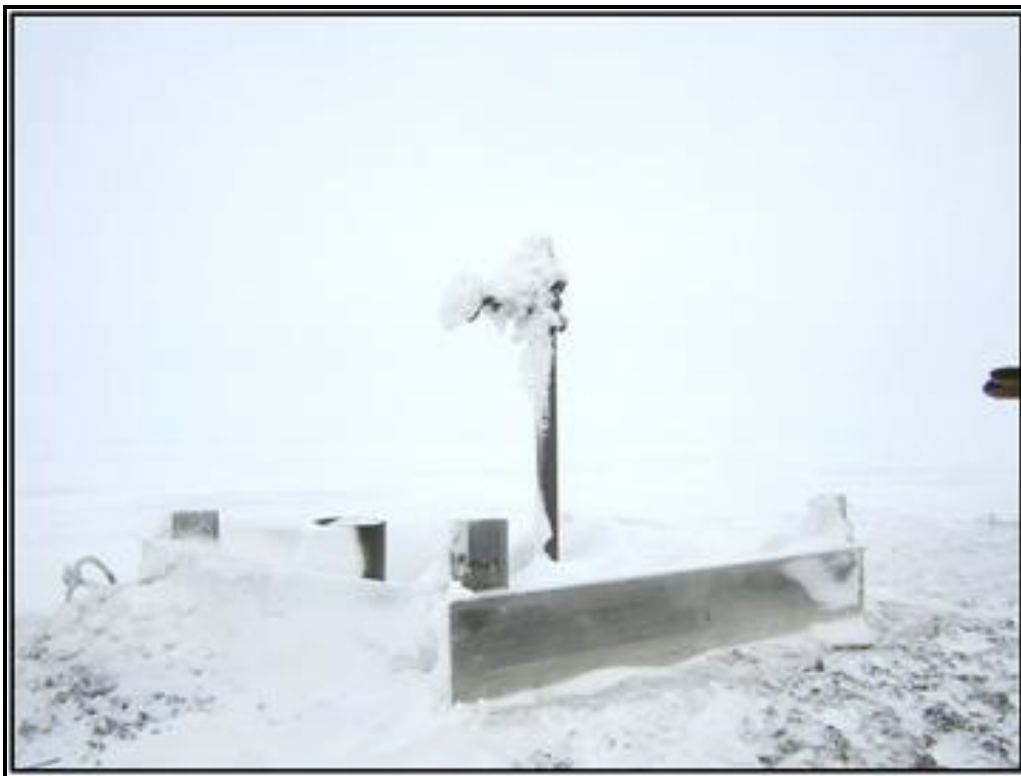
Figure 7: Wellhead at location – February 2010 – Facing Northeast

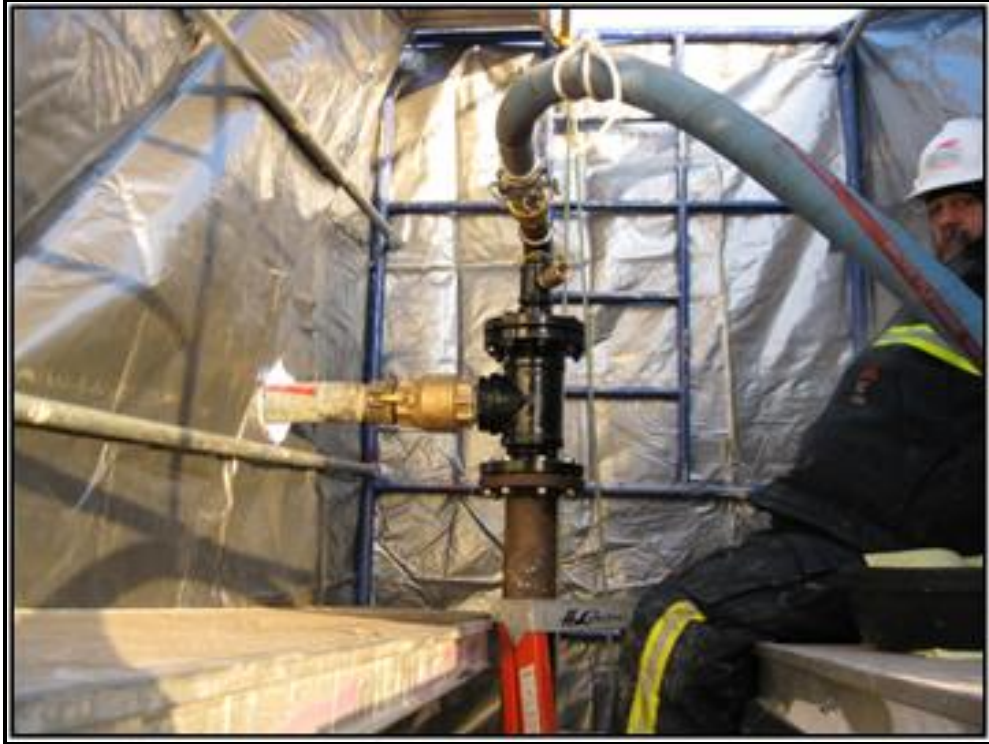
Figure 8: Displacing diesel with NaCl water – February 2010

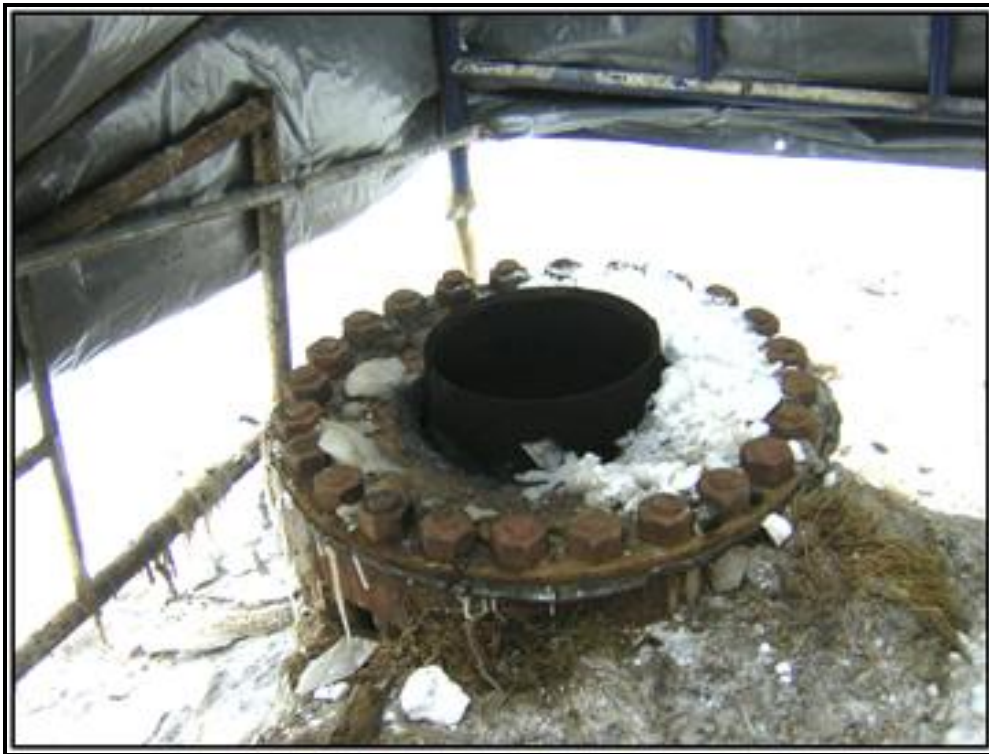
Figure 9: Wellhead cut off after diesel displaced with NaCl water – March 2010

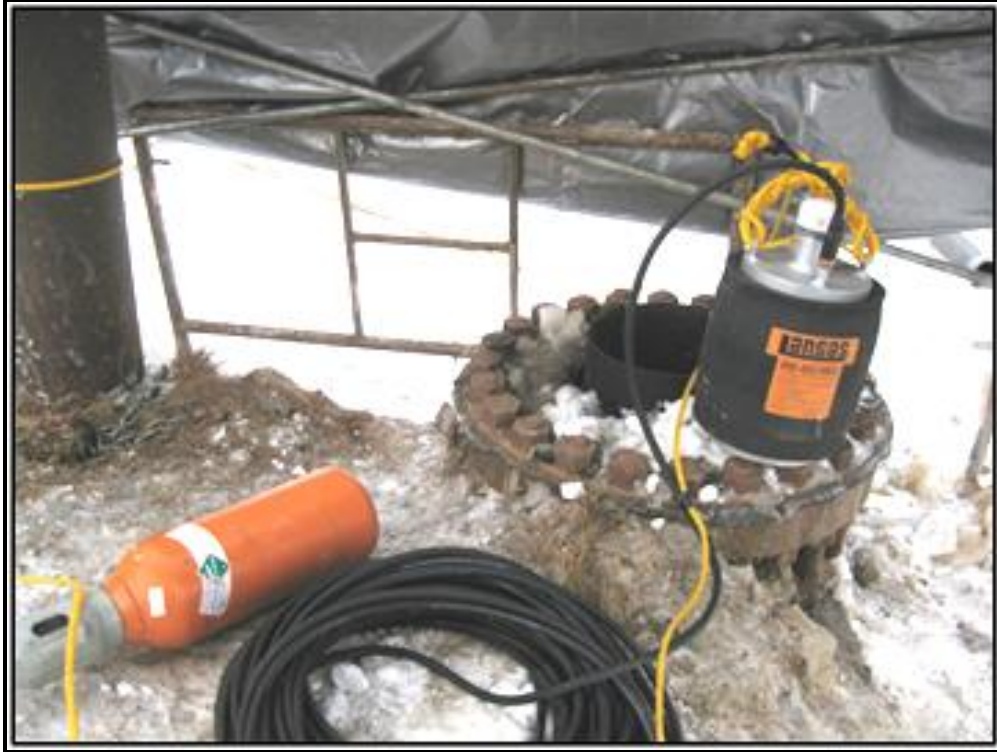
Figure 10: Preparing to lower and set inflatable plug at 114 feet BGL - March 2010

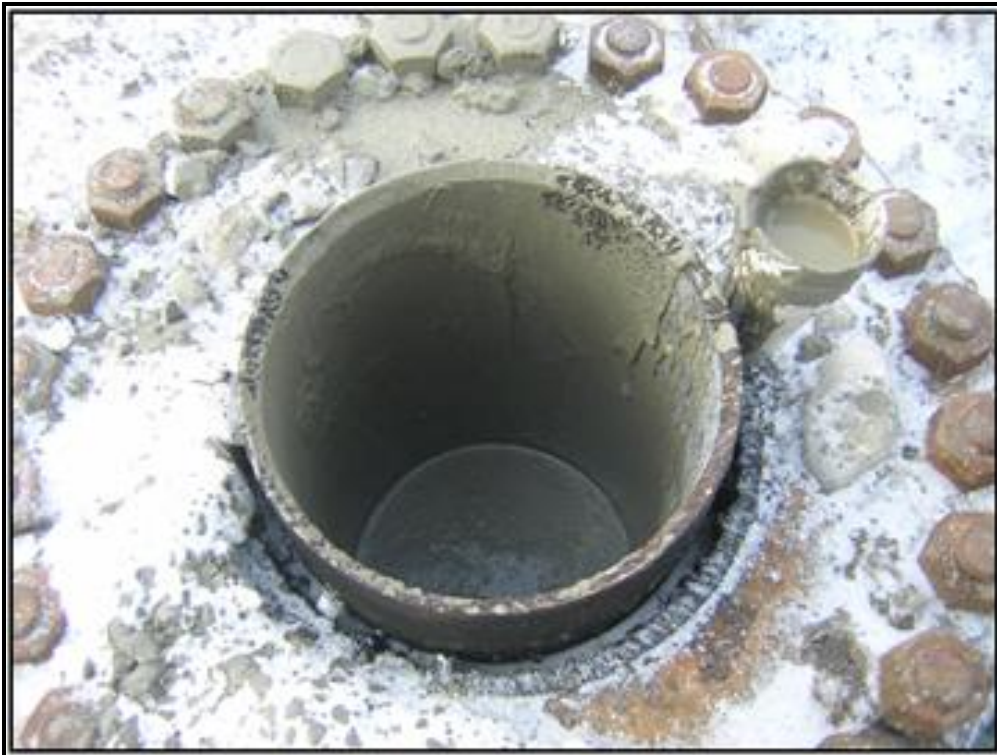
Figure 11: Wellhead after cementing to surface and before excavation – March 2010

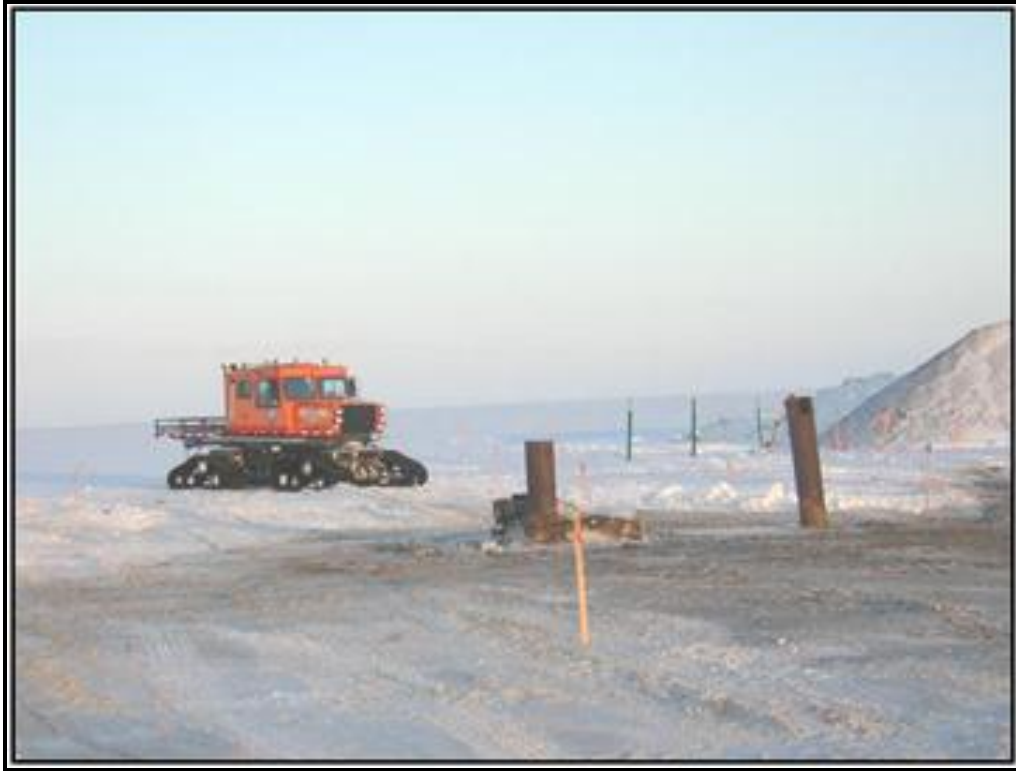
Figure 12: Wellhead location after clearing PxA equipment – March 2010

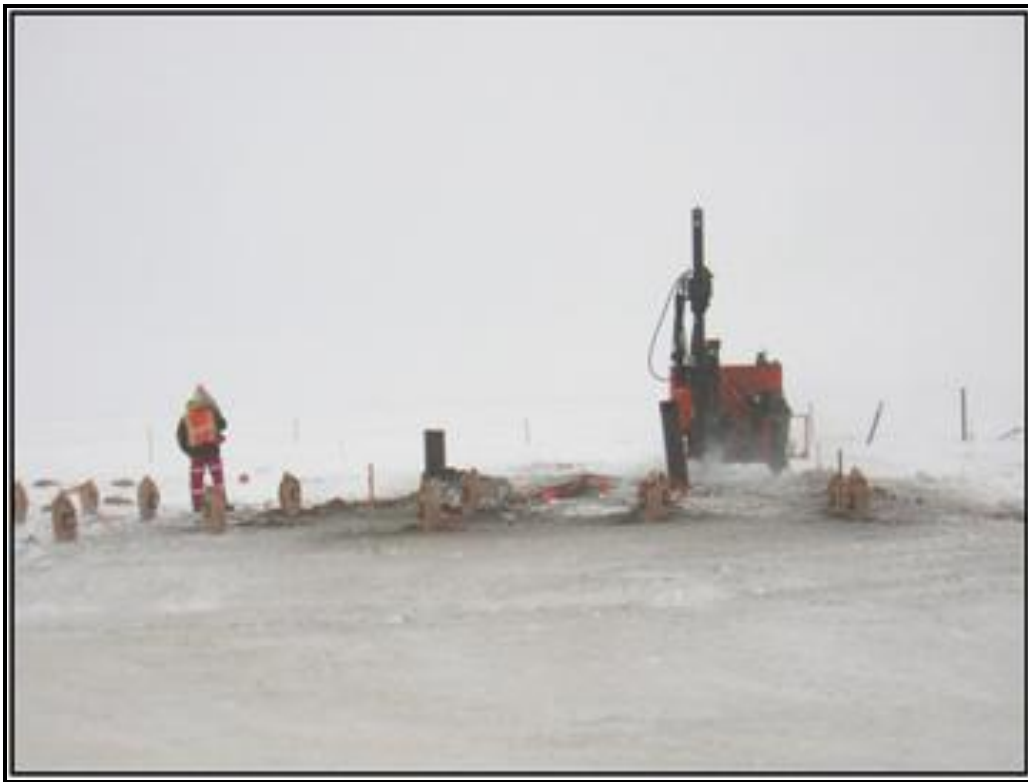
Figure 13: Preparing for first drill and shoot blast and excavation – March 2010

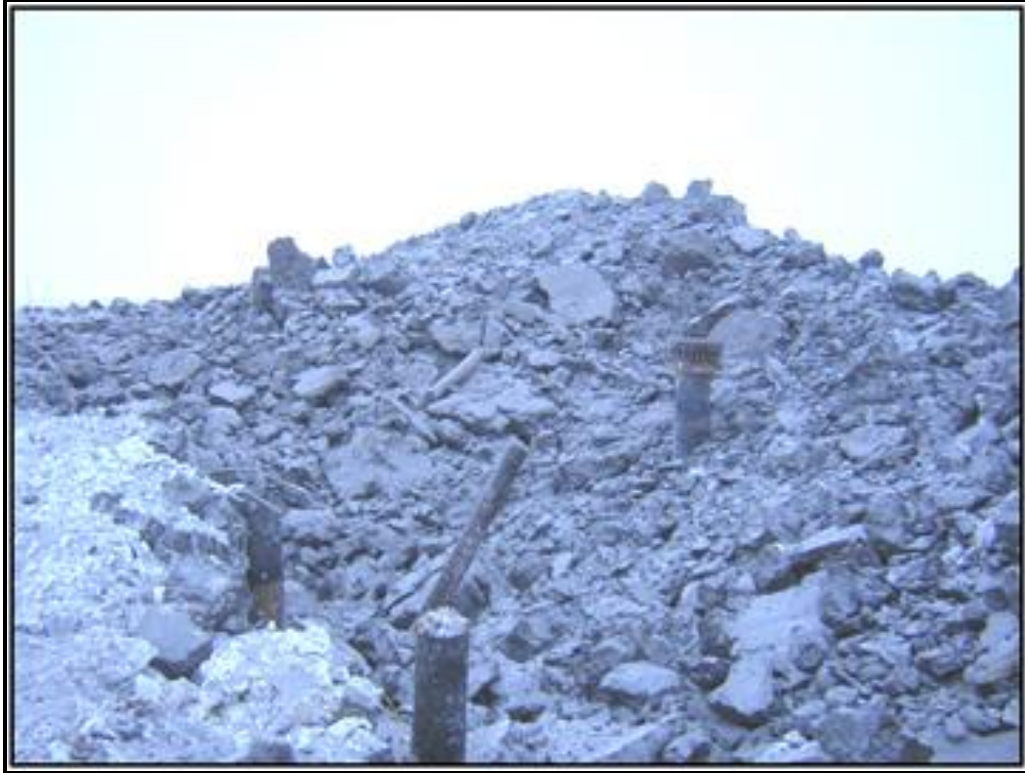
Figure 14: Well location after first drill and shoot blast – March 2010

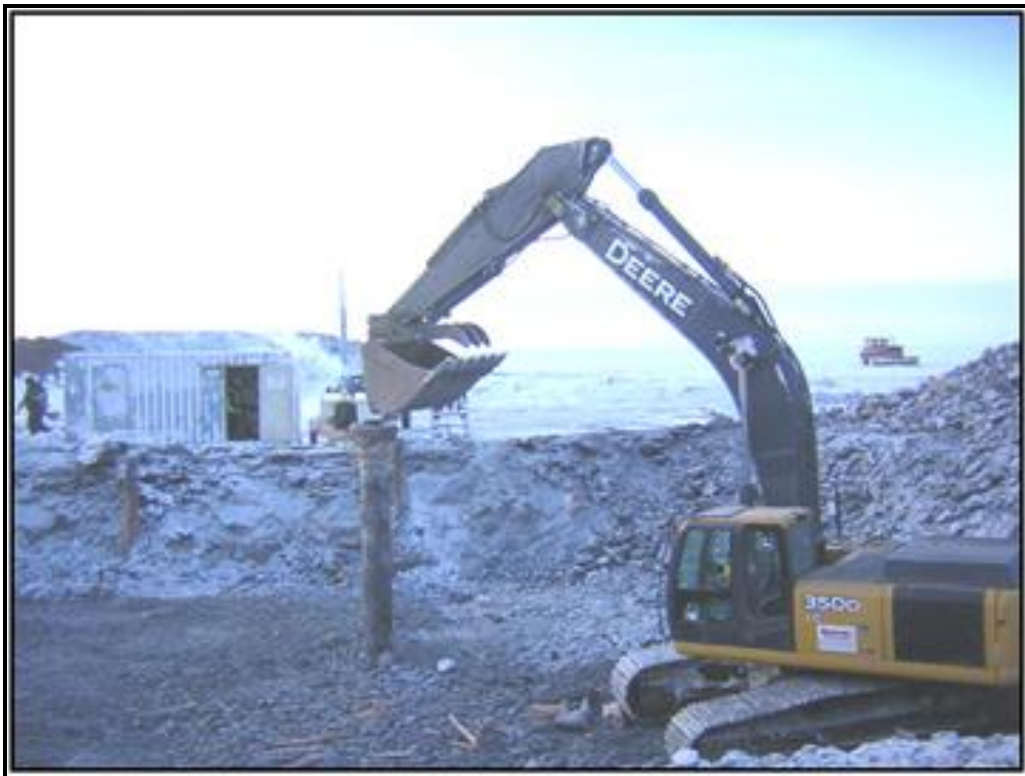
Figure 15: Wellhead location after cleanout to 14 feet BGL after first drill and shoot – March 2010

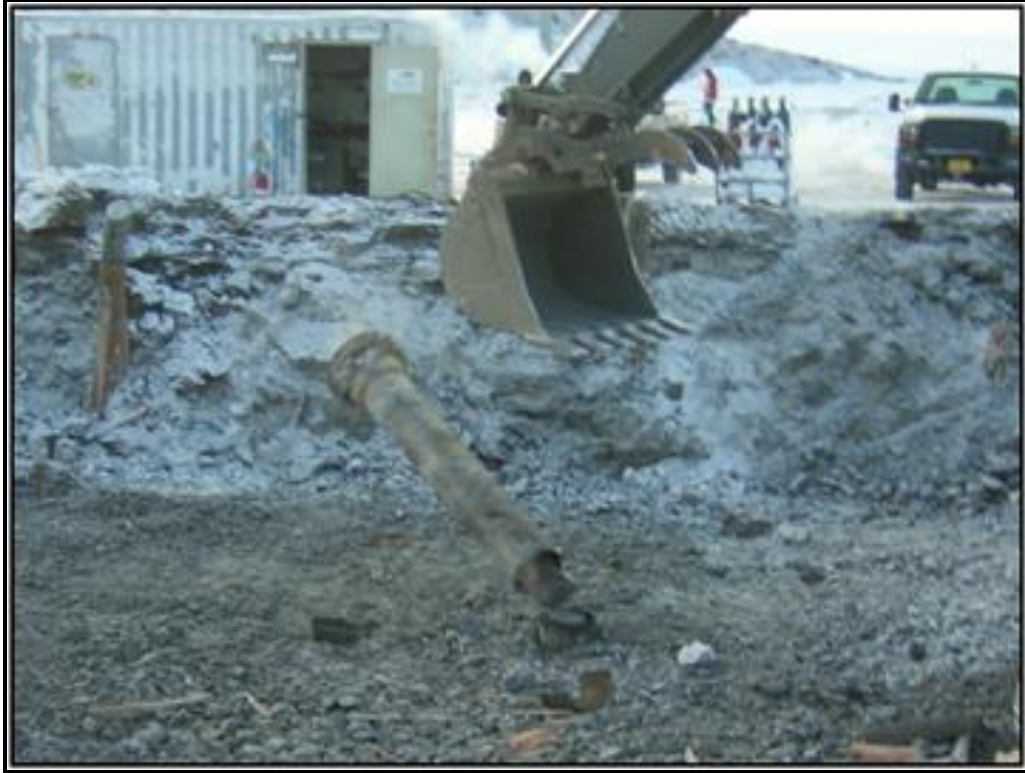
Figure 16: Cut off first wellhead section at 13 feet BGL – March 2010

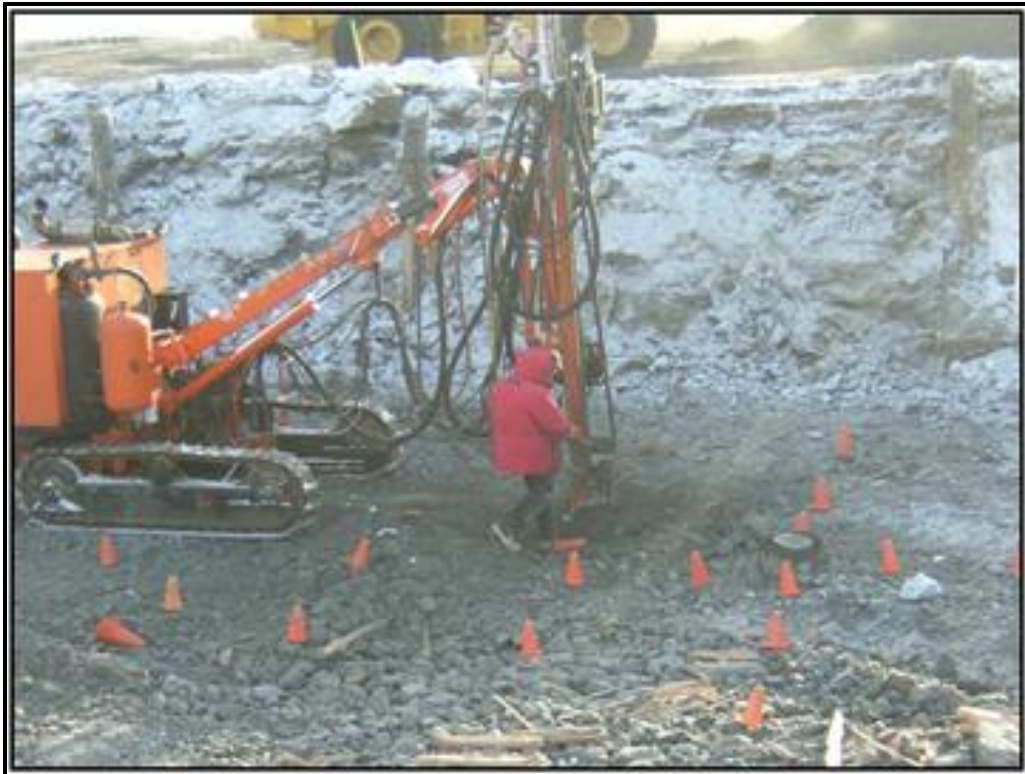
Figure 17: Preparing for second drill and shoot blast and excavation – March 2010

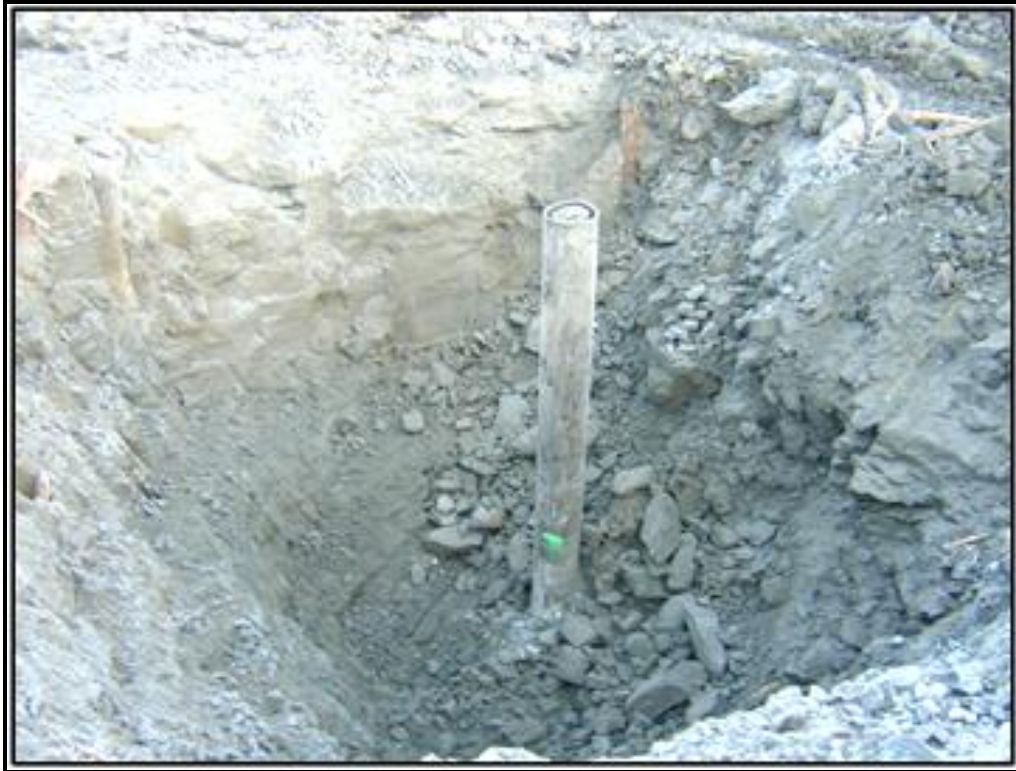
Figure 18: Final excavation to 30 feet BGL (green line at 5 feet below MSL) – March 2010

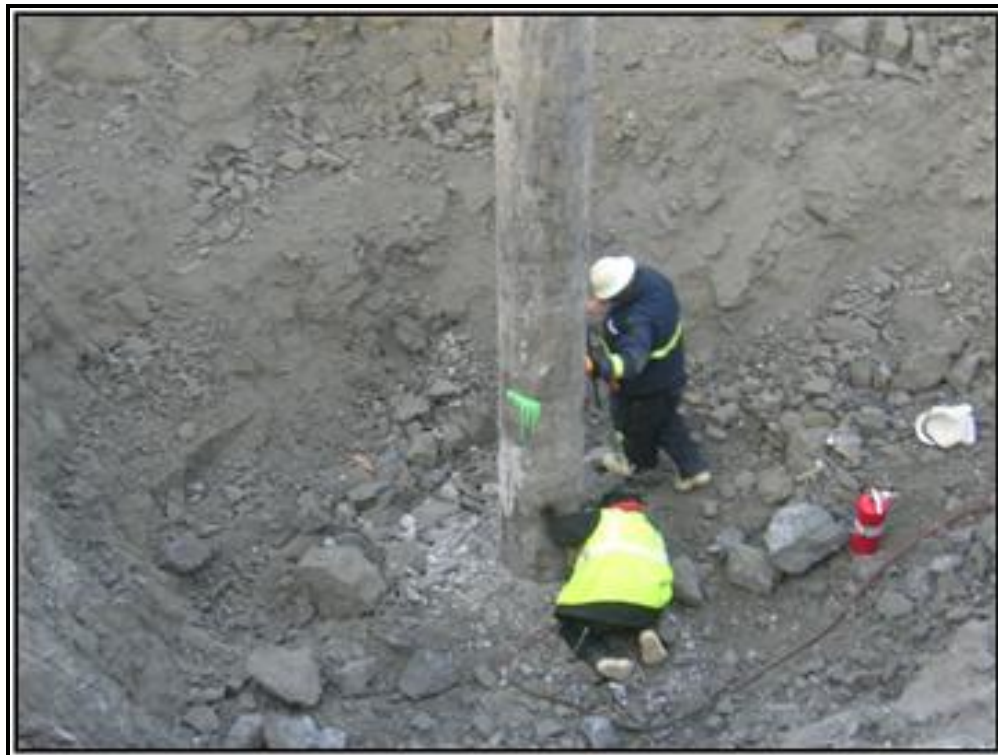
Figure 19: Cutting off second wellhead section at 29 feet BGL (8 feet below MSL) – March 2010

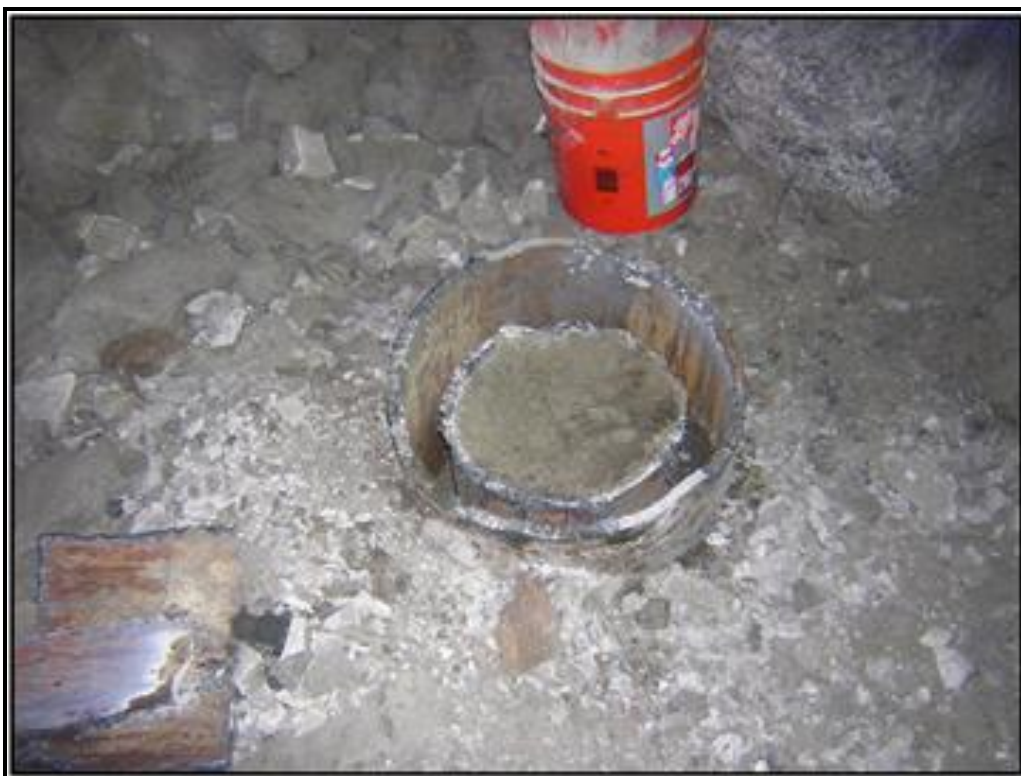
Figure 20: Final wellhead cut off at 29 feet BGL with 6 inch deep annulus void – March 2010

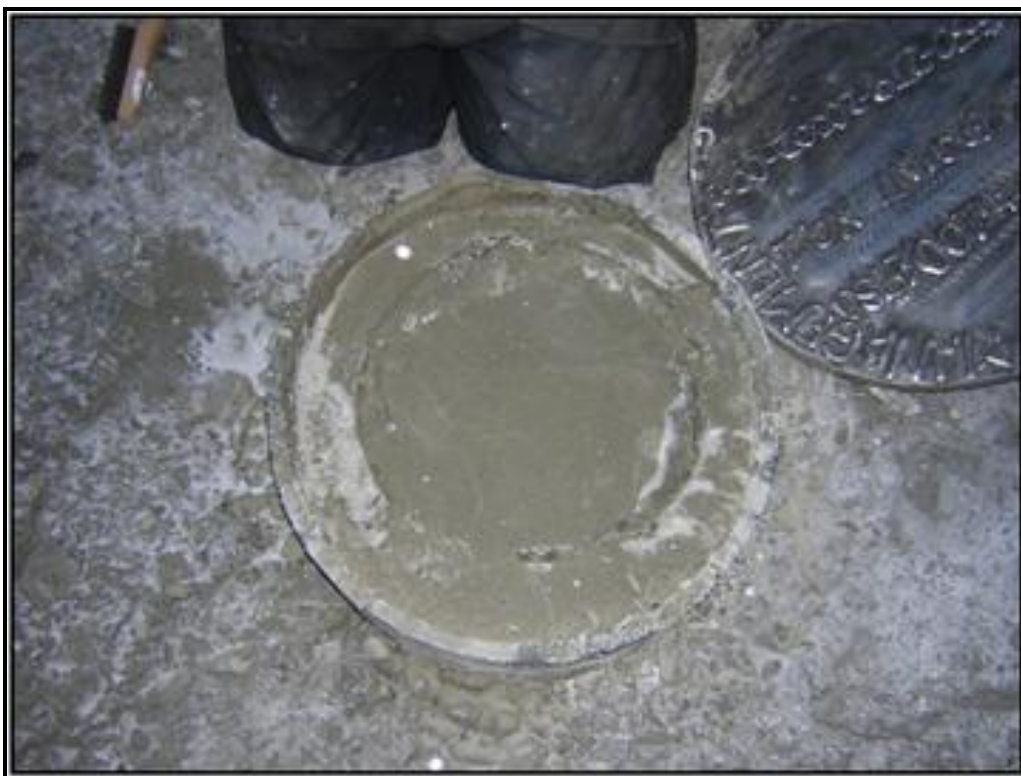
Figure 21: Final wellhead cut off at 8 feet below MSL and 13-3/8"x 20" annulus filled – March 2010

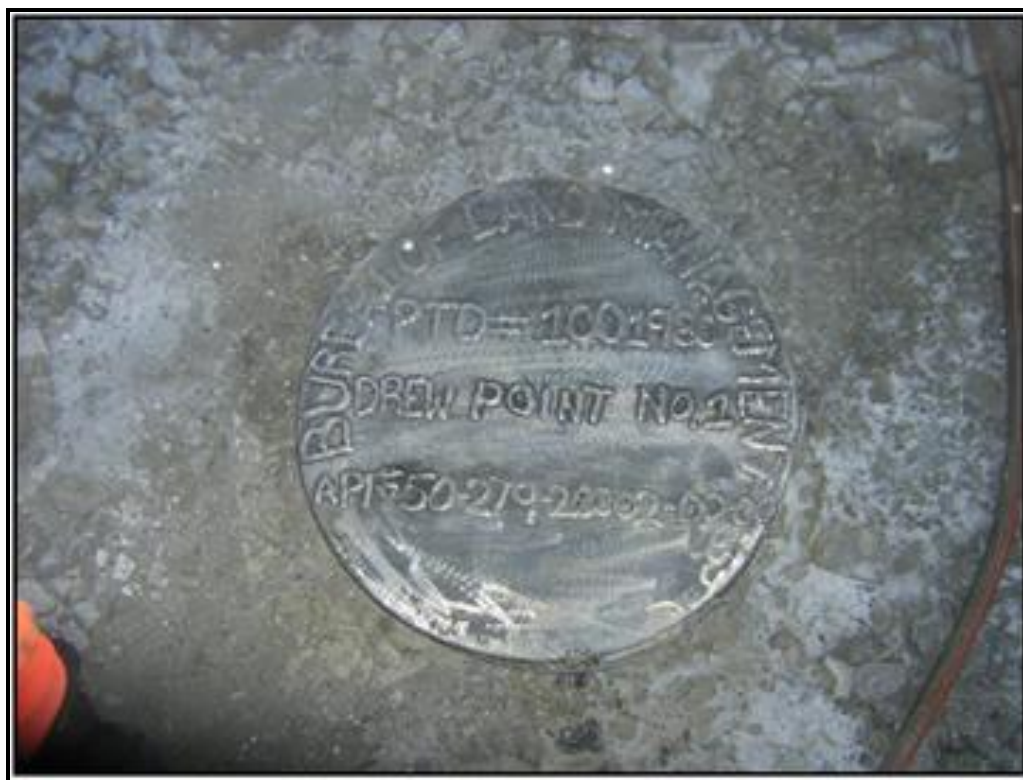
Figure 22: Wellhead ID marker plate installed – March 2010

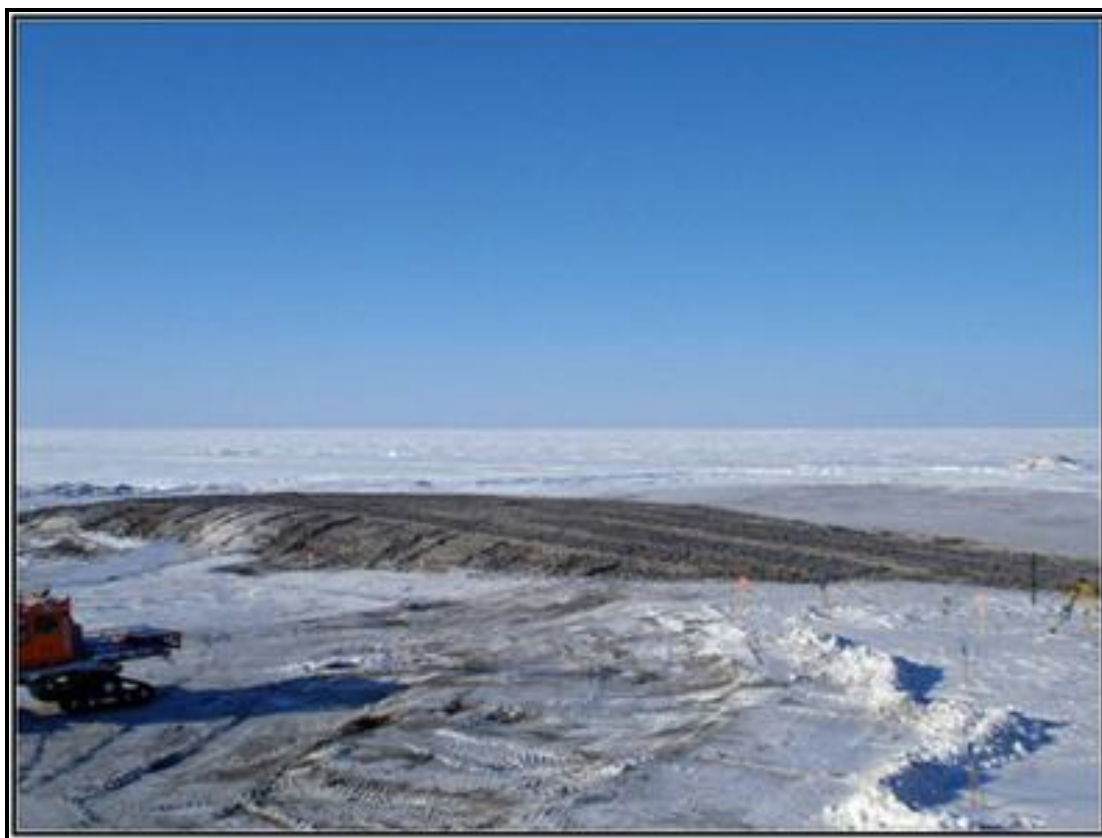
Figure 23: Final well surface location after backfilling cellar and mounding location – March 2010
